Errata and Added Information to MC68360 Quad Integrated Communication Controller User's Manual Rev 1

January 8, 1998

This document describes the latest information and changes to the first revision of the MC68360 user's manual.

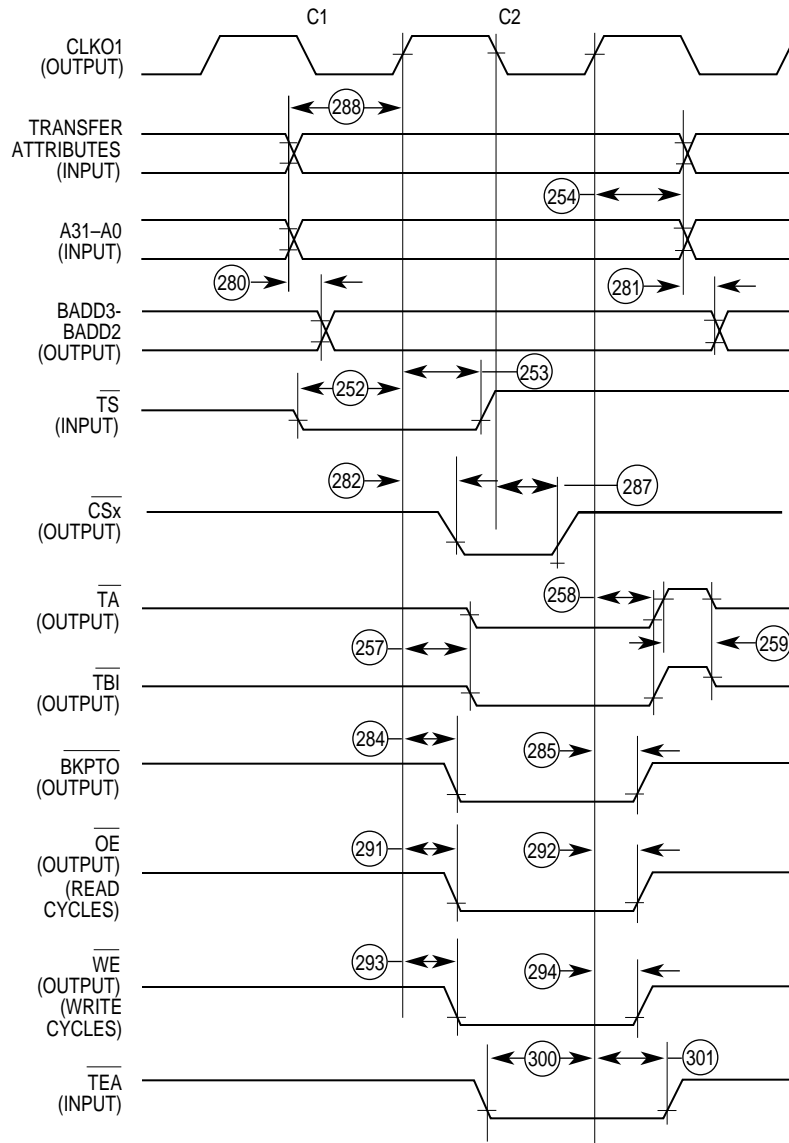
Figure 10-44(b) MC68040/EC040 SRAM Write cycle (TSS40=0, CSNT40=1)

The following figure should be added after figure 10-44(a)

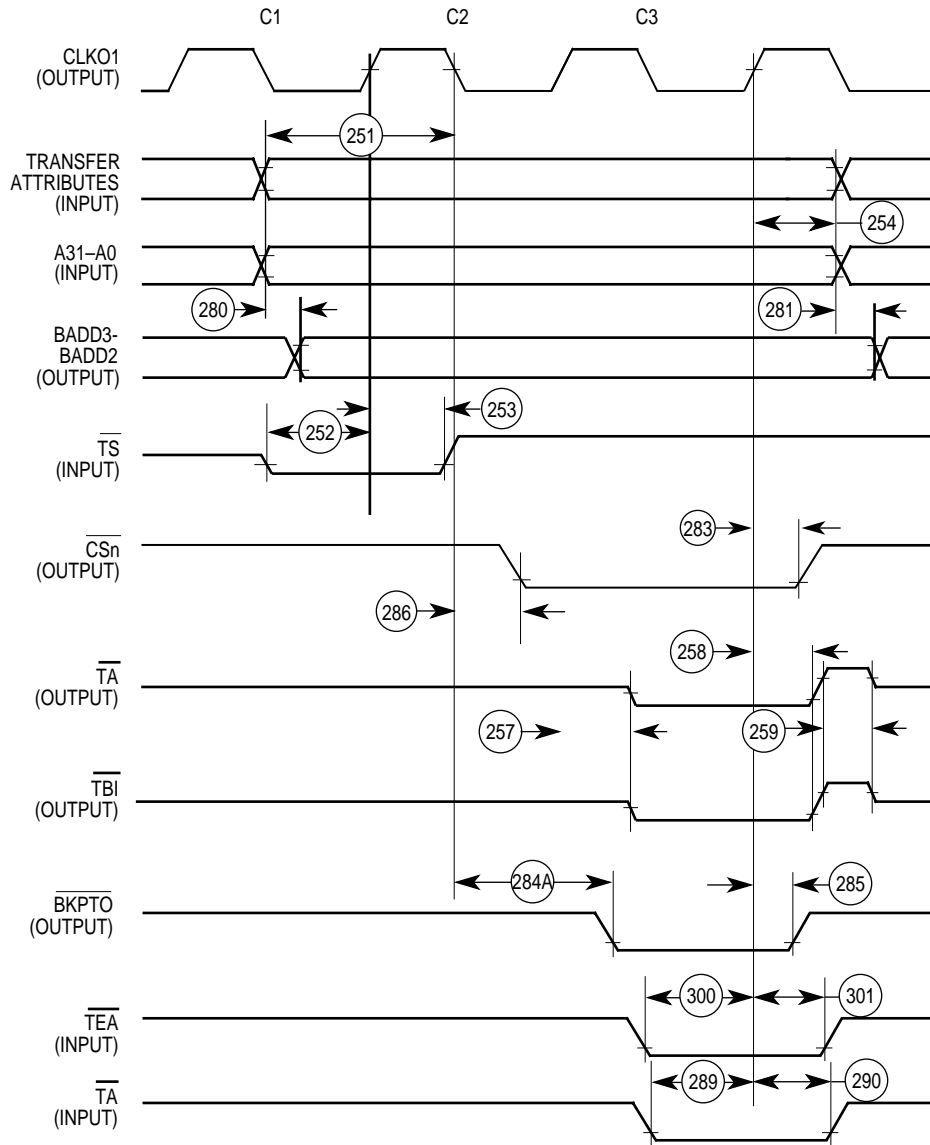
Figure 10-45(b) MC68040/EC040 SRAM Read Cycle (TSS40=1, CSNT40=1)

\overline{OE} and \overline{WE} signals are not supported when TSS40 is set to 1.

The following figure should be added below figure 10-45(a)
